## **DS Compact TBM dealing with complex and unexpected geology in Los Bronces Exploratory Tunnel**

In 2008 a new type of TBM system (Double Shield Compact TBM) was developed by SELI for the excavation of exploratory and hydraulic tunnels in variable rock conditions.

This type of TBM was selected by the Dragados-Besalco Consortium to excavate the 8 km long exploratory tunnel in Chile for Los Bronces mine, one of the largest copper mines in the world owned by Anglo American.

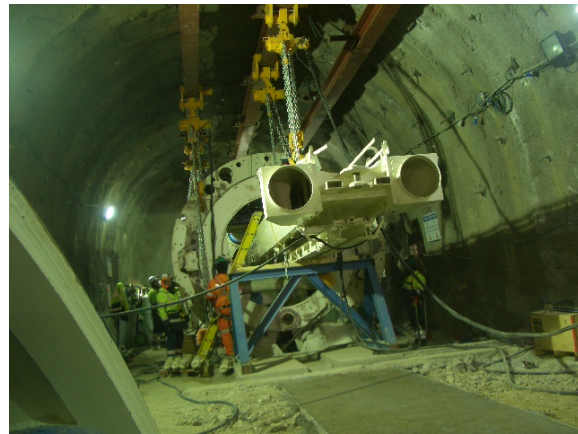
**Figure 7. Underground assembly**

The TBM was then assembled in a smaller than foreseen underground cavern and in August 2009 was ready to bore. To be noted the extremely severe working conditions imposed by the Client (Compulsory mine rules). For instance:

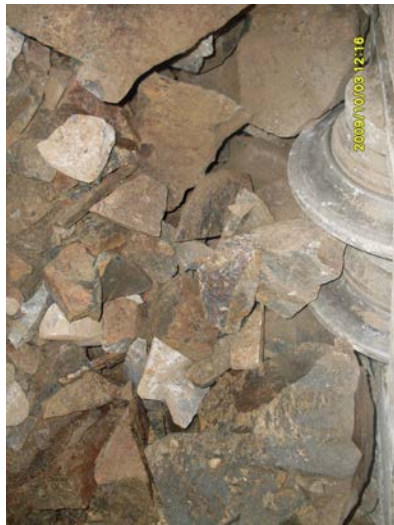
**Figure 9. Face collapse**

The TBM, immediately at the start of excavation (actually after a dozen of meters in relatively good rock) entered in a very disturbed area in very adverse geological conditions with continuous face collapses. Basically the TBM had to cross a very intensively faulted zone with prismatic fragments of rock having a size of few centimetres size mixed with clayish material. No water inflows were experienced in this area, although the filling material was saturated. No cohesion, no friction. The TBM excavation was performed with no significant pressure on the main thrust cylinders.

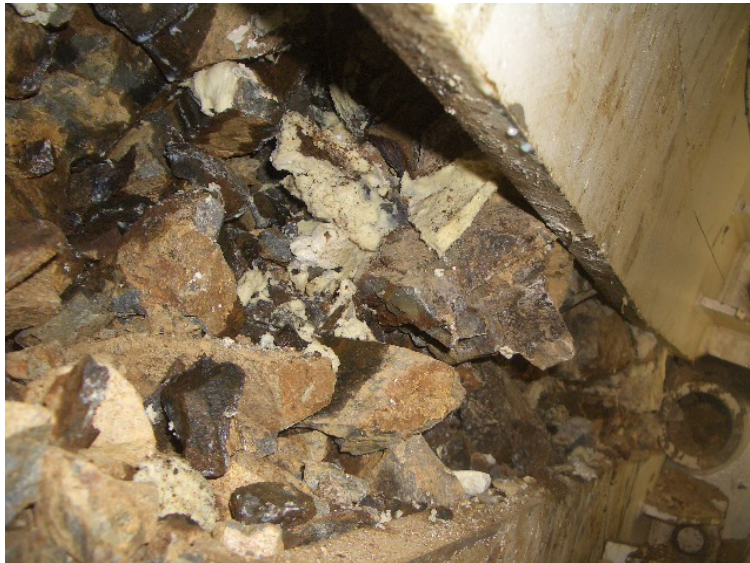
**Figure 11. Collapse at the rear shield**

The installation of liner plates, as primary support, was immediate as well as the foam injection through the cutterhead to fill cavity created by the collapsing ground. Despite the high rock instabilities the TBM was always in the condition to use gripper pads to advance and it was not necessary to utilise the Single Shield Mode.

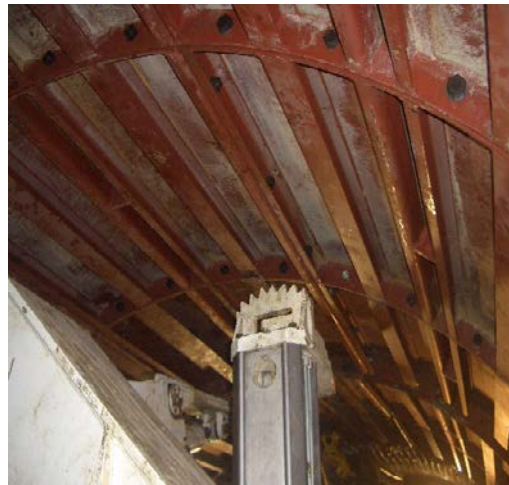
**Figure 14. Steel set roof erection**

A dedicated mechanical erector boom was installing the liner plates, thus leaving the crew always in safety position during critical operations. Sometimes foam injection has been required even to fill gap between the liner plates and the rock.

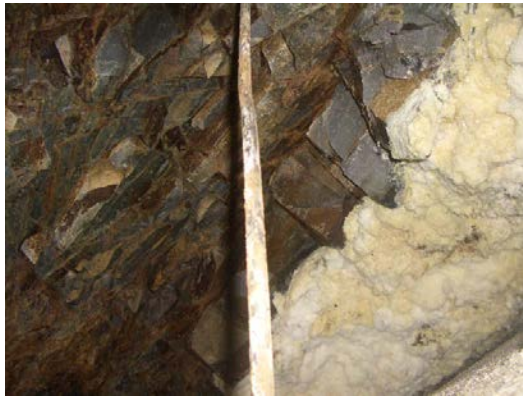
**Figure 15. Filling cavity at the front face**

The foams were used in this initial faulty area to fill the voids and consolidate/support the tunnel face.

The injected material was a fire-resistant bi-component foam (ratio 1:1) with an expansion rate up to 10 times of the initial volume and a reaction time of 30 sec. Hardening is reported between 2 and 5 minutes. The expansion reaction is not affected by water presence.

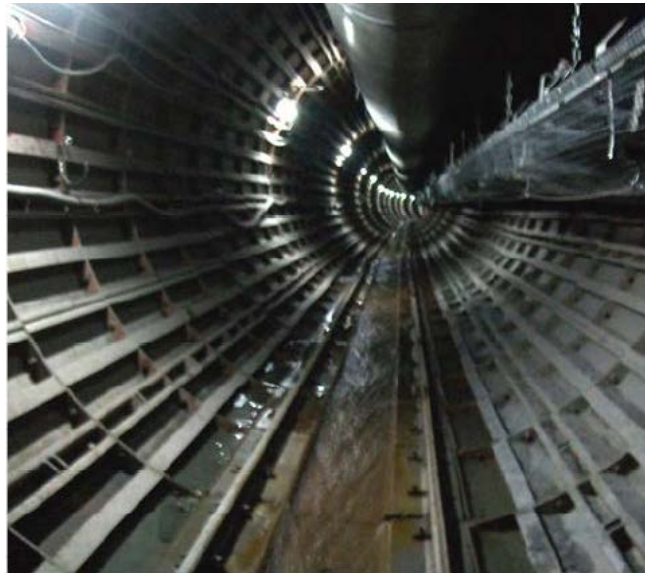
**Figure 19. Rock support CS5**

- Extension of the fingers of the tail shield to support the rock while assembling the liner plates.
- Strengthening of the TBM conveyor's hopper, its supports, its structure to better resist to the continuous shocks of the rock blocks entering the cutterhead.
- Overcutting by spacing out the three peripheral cutters that were displaced up to 2 cm and increase excavation diameter

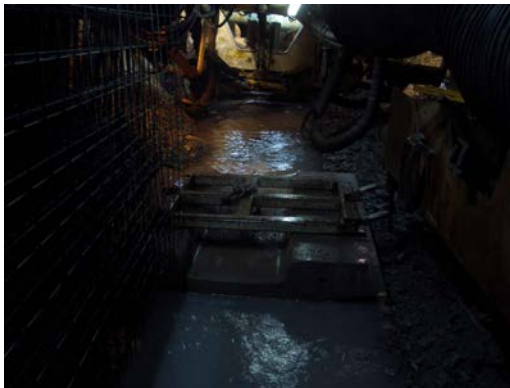
**Figure 21. Water and debris at the invert placing**

Despite the alignment modification, the TBM, after having advanced about 300m in reasonably good rock, encountered very heavy water inflows in excess of 100 lt/sec at the face. Although it was not a overwhelming quantity, the inflow was carrying a lot of rock debris complicating the invert cleaning and the segment installation. Additional pumping stations were installed as well as a 400mm diameter steel pipe up to the external portal to avoid flooding of the underground yard's structure.

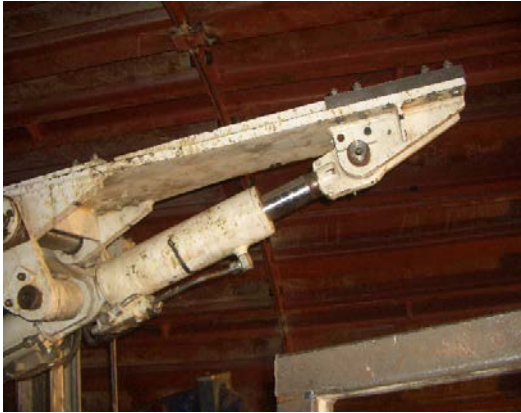
**Figure 23. Probe drill's dedicated boom**

Probe drill was regularly performed and overlapped to detect and drain water in advance.

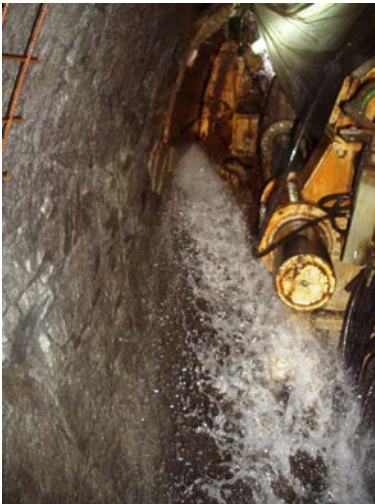
**Figure 25. Concentrated water inflow**

Similar occurrences (150 lt/sec) appear from chainage 1290 to 1600 (aprox. 1140-1450 of the original alignment). From chainage 1600 up 2340 minor water inflows (up to 50 lt/sec) were recorded.
