# **EPB TBM UNDER THE CITY CENTRE OF VANCOUVER: RISK MANAGEMENT AND SETTLEMENT CONTROL**

Andrea Ciamei and Marco Moccichino

**Keywords:** urban tunnelling, risk management, settlement control

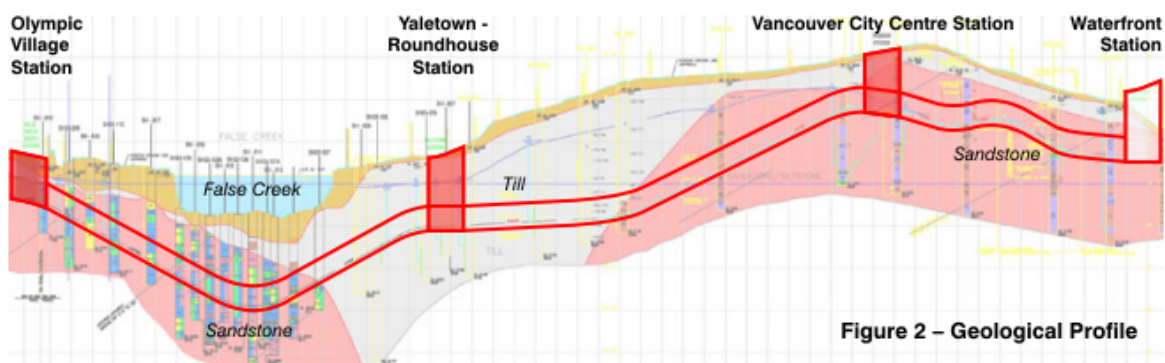
Figure 2 – Geological Profile

The tunnels negotiate several combined vertical and horizontal curves with radii as tight as 212m through the most difficult section of the alignment. An aerial view of the alignment can be seen in Figure 1. Both inbound and outbound tunnels were driven northwards from the tunneling operations pit. The tunnels' alignment dips steeply after exiting the start pit, passing from rock to soil under False Creek, and continues in soil for 750m before reentering the rock for the remainder of its length. Figure 2 shows the geological profile.

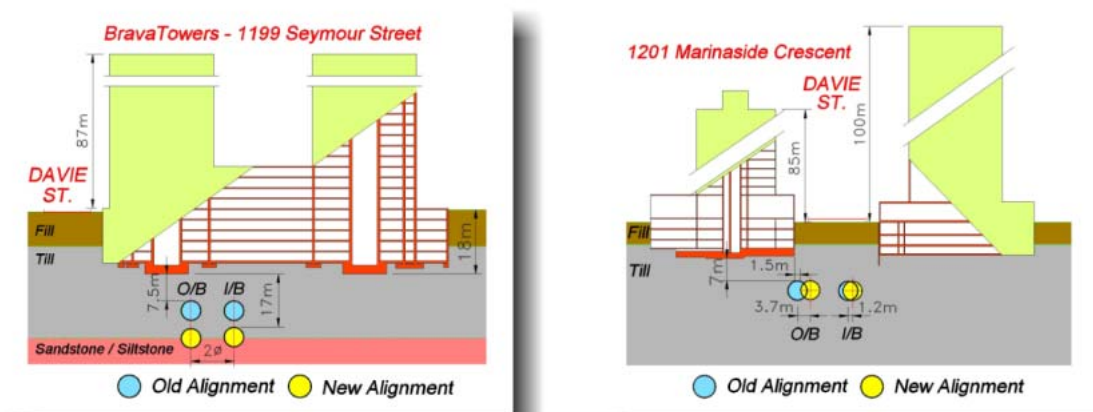
Figure 4– Shift in alignment implemented after Risk Assessment

Five distinct areas were identified as having higher than acceptable risk, all due to the location of the tunnel relative to the raft foundations of buildings and the possible local occurrence of unfavorable ground conditions. The compounding factors for the first two buildings were that they were adjacent to the shore of the “river like” False Creek and, as the transition from sandstone to till was under False Creek, the influence of tunnel boring within the till had not been measured and the elastic modulus had only been assessed by back-calculation and not testing. The tunnel was located slightly under the buildings with as little as 7m of till between the crown and foundations. Although the vertical alignment could not be changed beyond the maximum 5.5% gradient required to reach the next station, the horizontal alignment could be changed to move the tunnel outside of the building. Figure 4 shows the shift in alignment for these two buildings. Two multipoint extensometers were also installed onshore immediately before and after the first building to assess ground behavior while boring under the designed boring parameters.

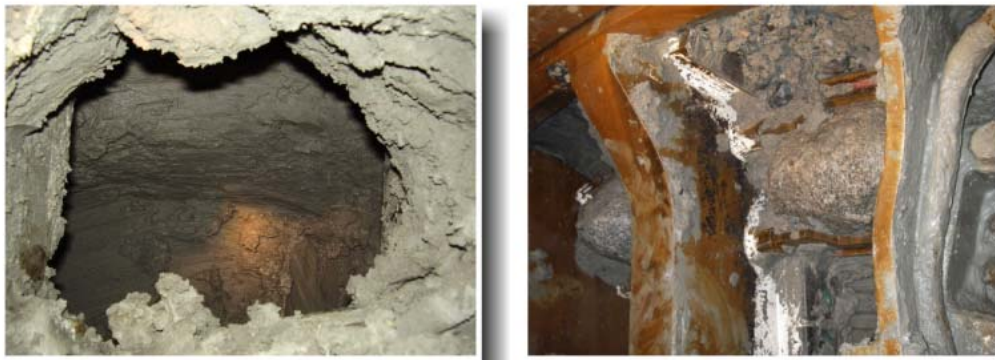
*Figure 5 – Strong impervious till and boulders stuck between intact grizzly bars*

The transition from sandstone to till went smoothly without any geological anomalies becoming apparent. Once the machine was wholly in the till face inspections, under atmospheric pressure, showed the face to be comprised of strong impermeable till. These conditions continued as the TBM approached the shoreline of False Creek and the loss of ground indicated from the first inclinometer was less than 0.5% and building movement limited to a maximum of 4mm. Shortly after, the screw conveyor became blocked on several occasions by boulders. At this stage the TBM was adjacent to the first building foundation and operating under a face pressure of approximately 1bar, so the screw blockage was cleared and excavation continued until the machine was clear of the building. It was known from observation of the extracted muck that the ground conditions were good so a cutting head inspection was done under atmospheric conditions. The cutting head was designed to allow boulders of maximum size of 300mm into the cutting chamber and into the screw conveyor. This was done by placing grizzly bars across the opening of the cutting head. It was apparent from cleaning out the blocked screw conveyor that larger boulders were entering the chamber. The face inspection showed that the grizzly bars had been knocked out (as they were only bolted in), allowing larger boulders to enter. To prevent this situation, all bolted grizzly bars were replaced by thick welded plate during an intervention that lasted several days. After this work, no large boulders entered the chamber but frequent face inspections were required to check if the openings were blocked by boulders and if so, they were removed. Figure 5 shows the strong impermeable till and boulders stuck in the 300mm openings where the grizzly bars had not been knocked out. No further screw blockages were encountered after replacing the grizzly bars.
